EXAMPLE

Typical Reports issued under the Detec Monitoring Services and Maintenance Option showing a typical 'moisture event'.

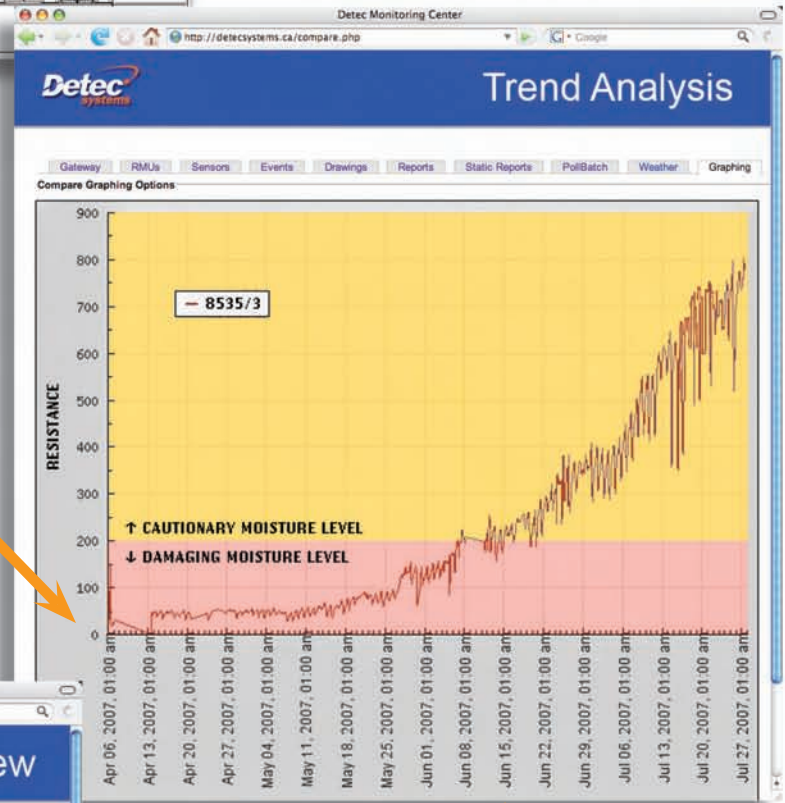
1. In April, Remote Monitoring Unit #8535 reported excessive moisture accumulation in zone #3. (shown in red)

2. In this example, water from a blocked roof drain downspout was wicking up the sheathing behind the exterior cladding, *although no visible clues indicated a problem.*
